NRL Memorandum Report 1378

# THE PERFORMANCE OF LEAD-SILVER ANODES IN CATHODIC PROTECTION OF RESERVE FLEET VESSELS AT THE SAN DIEGO GROUP, PACIFIC RESERVE FLEET

L. J. Waldron

December 1962

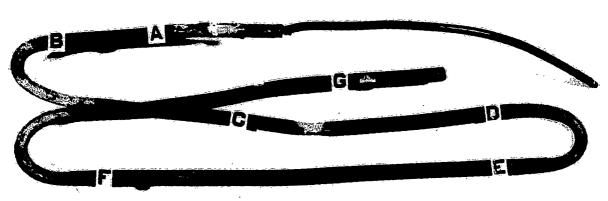
(a) One-half inch diameter lead-silver rod. Three of these 6-foot long anodes were examined after various periods of service. The first, Figure 1, was removed on 21 December 1961 after 255 days of service during which it had passed 26,000 ampere-hours of current for an average of nearly 5 amperes (7 amps/sq. ft.). The lead wire splice has been uncovered in this photograph to show the details of the joint, which was in excellent condition. Flexing of the anode in service has

caused the coating to peel off in spots with slight reduction in the diameter. The minimum diameter of the rod at any of these areas was approximately 7/16 inch. The brittleness of the coating is evidenced by its flaking where the anode was bent after removal from service. Figure 2 is a cross-section view of location "E" of Figure 1 and shows the coating which was estimated to be 15-20 mills thick.

Fig. 1 - View of six-foot length of 1/2-inch diameter lead-silver anode after 255 days of service. x 1/2

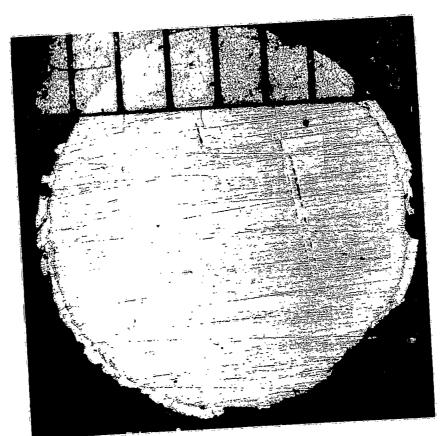
Fig. 2 - Cross-sectional view of location "E" of Fig. 1. x8 Each division of the scale - 1/16-inch.
